# Red and Bonita Mine

Removal Assessment Summary

February 2014

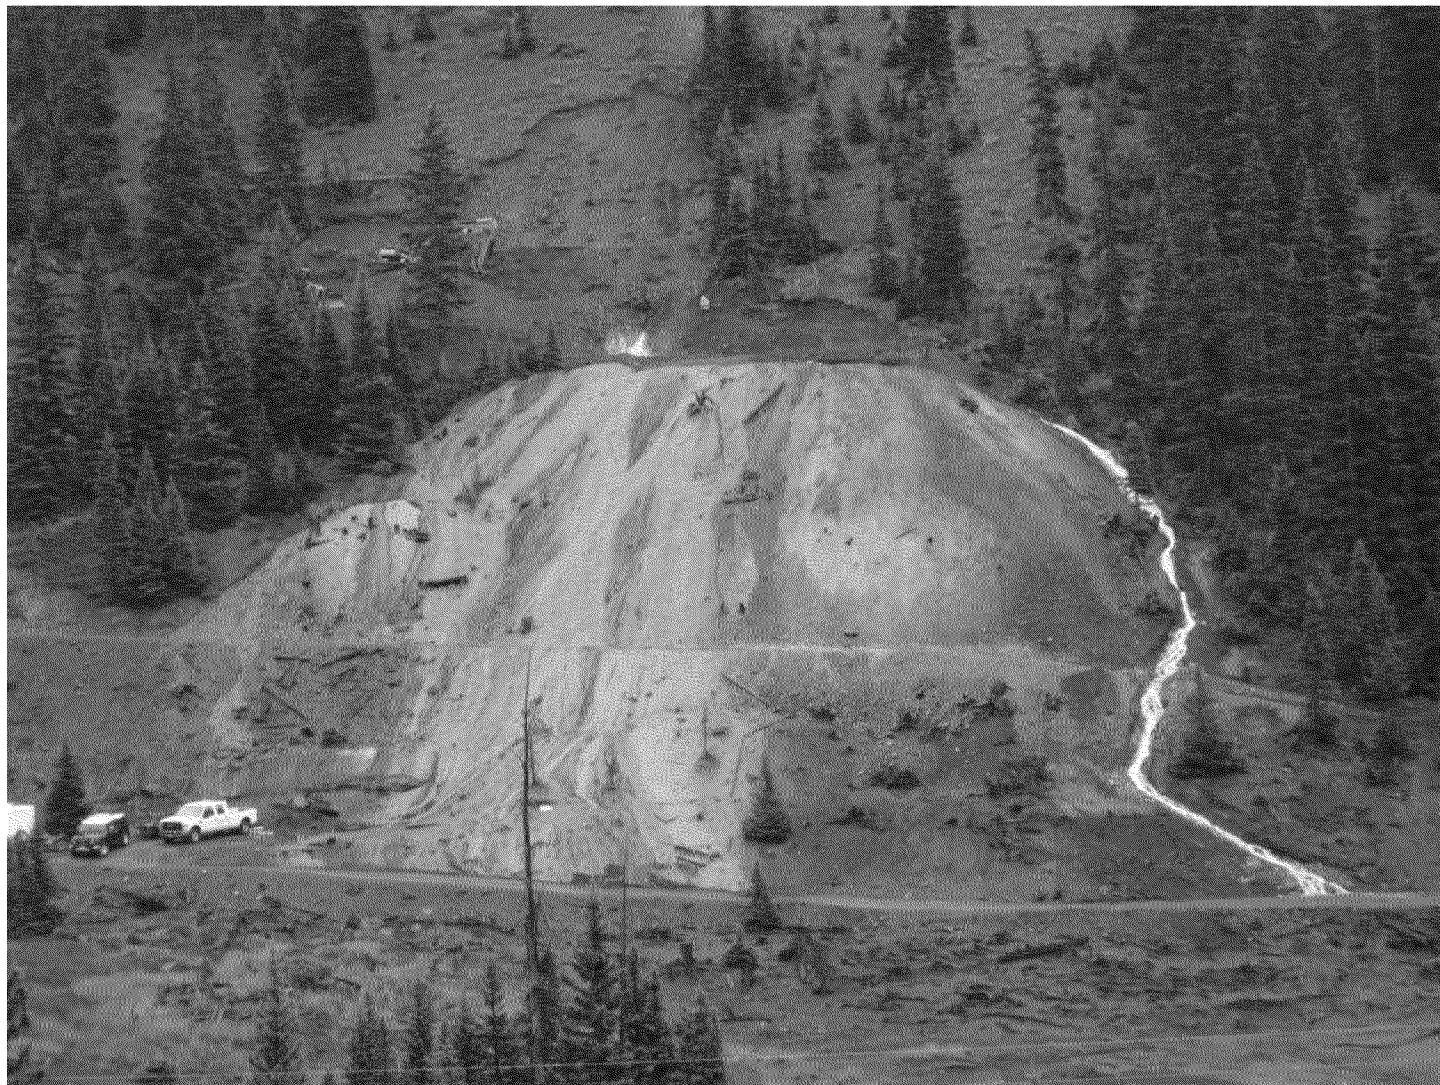
# Red and Bonita Waste Dump and Adit Flow
